## Deployment of the Northern Fish Cage and Mooring, University of New Hampshire — Open Ocean Aquaculture Program Summer 2000

**WHOI-2001-01**

**Technical Report**

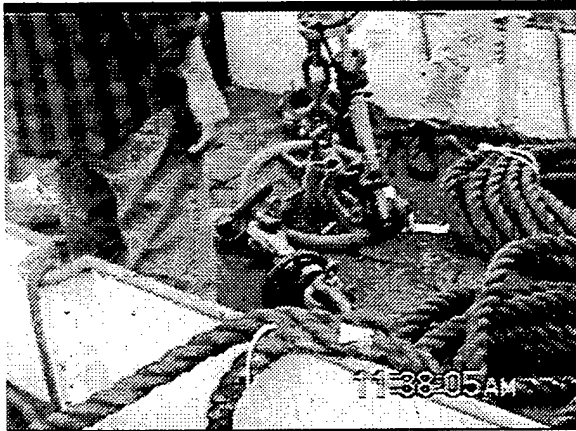
Picture 36. Northeast corner grid ring with four load cells and recorder strongback.

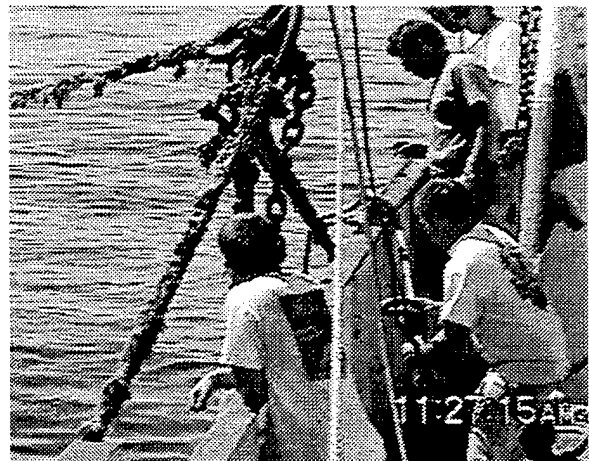
Picture 41. The Northeast grid corner ring with tangled lines and biofouling is recovered and untangled. Wear on the lower grid line is seen in upper left.

The South Cage mooring was inspected by divers earlier in the month and they found that the northeast lower bridle line was fouled around the corner buoy (Picture 41). This was untangled, but was redeployed with a badly chafed rope splice. Afterwards, the old remaining spar crown buoys (northeast and southeast) were brought on board and cut into several pieces for storage. The old buoys were replaced with 37-inch polypropylene floats and shorter chain adjustment links added. The northwest and southwest crown buoys (polypropylene floats) were also pulled and shorter adjustment chain replaced the old crown line chain. Upon replacement of each crown line chain, the *Nobska* would pull and tighten the anchor leg.

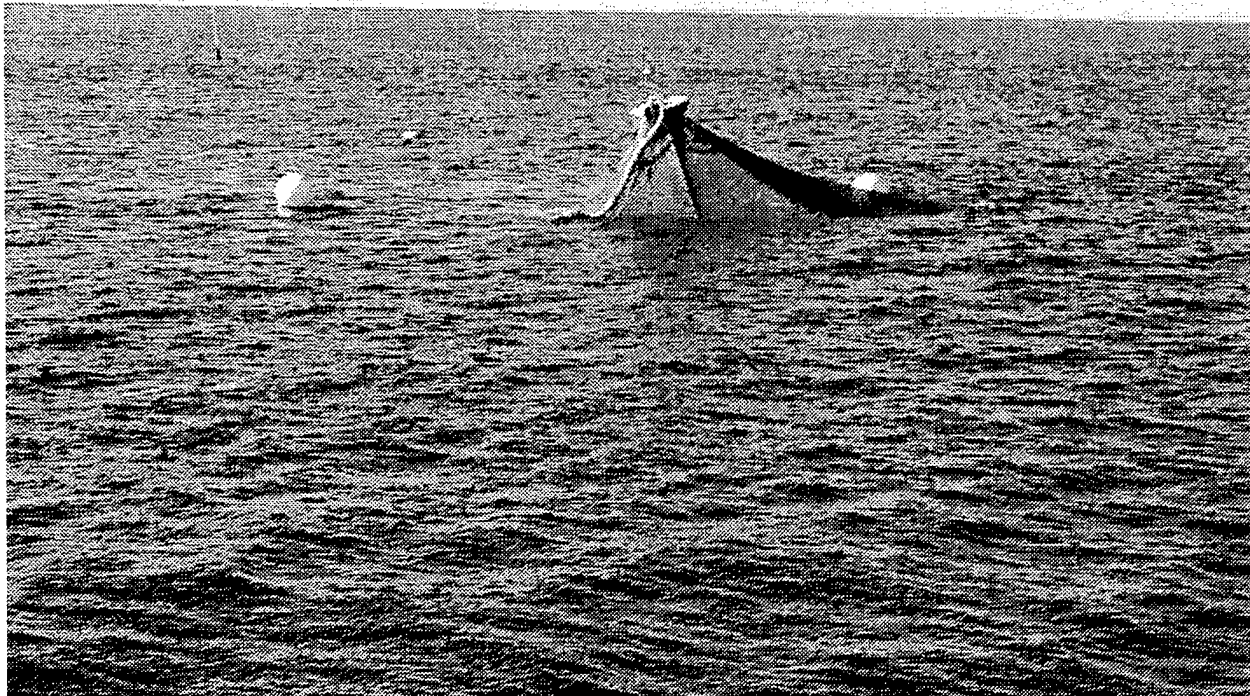
*Photo P001166 - the fish cage after the counter weight was removed and the grid relaxed. The cage floated with a marked list to one side.*

0800 - *Nobska* picked up the crown line marker buoy "A" and relaxed the grid until the steel grid floatation balls were observed on the surface. The fish cage floated with a marked tilt (see photo P001166 below).

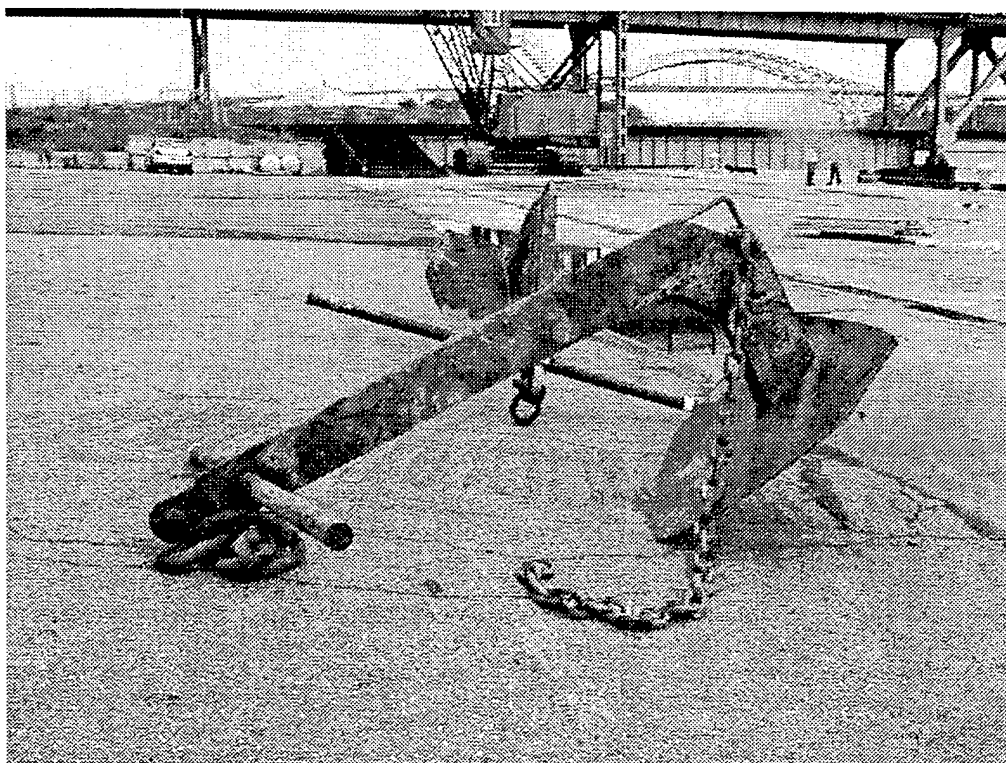
*Photo P001258 - Anchor from leg "D." This anchor was fully embedded and the mud line can be seen running forward from where the crown chain attaches to the anchor.*
